MINISTRY OF DEFENSE BUILDING
BAGHDAD, IRAQ

SUSTAINMENT ASSESSMENT

SIGIR PA-07-102
JULY 17, 2007

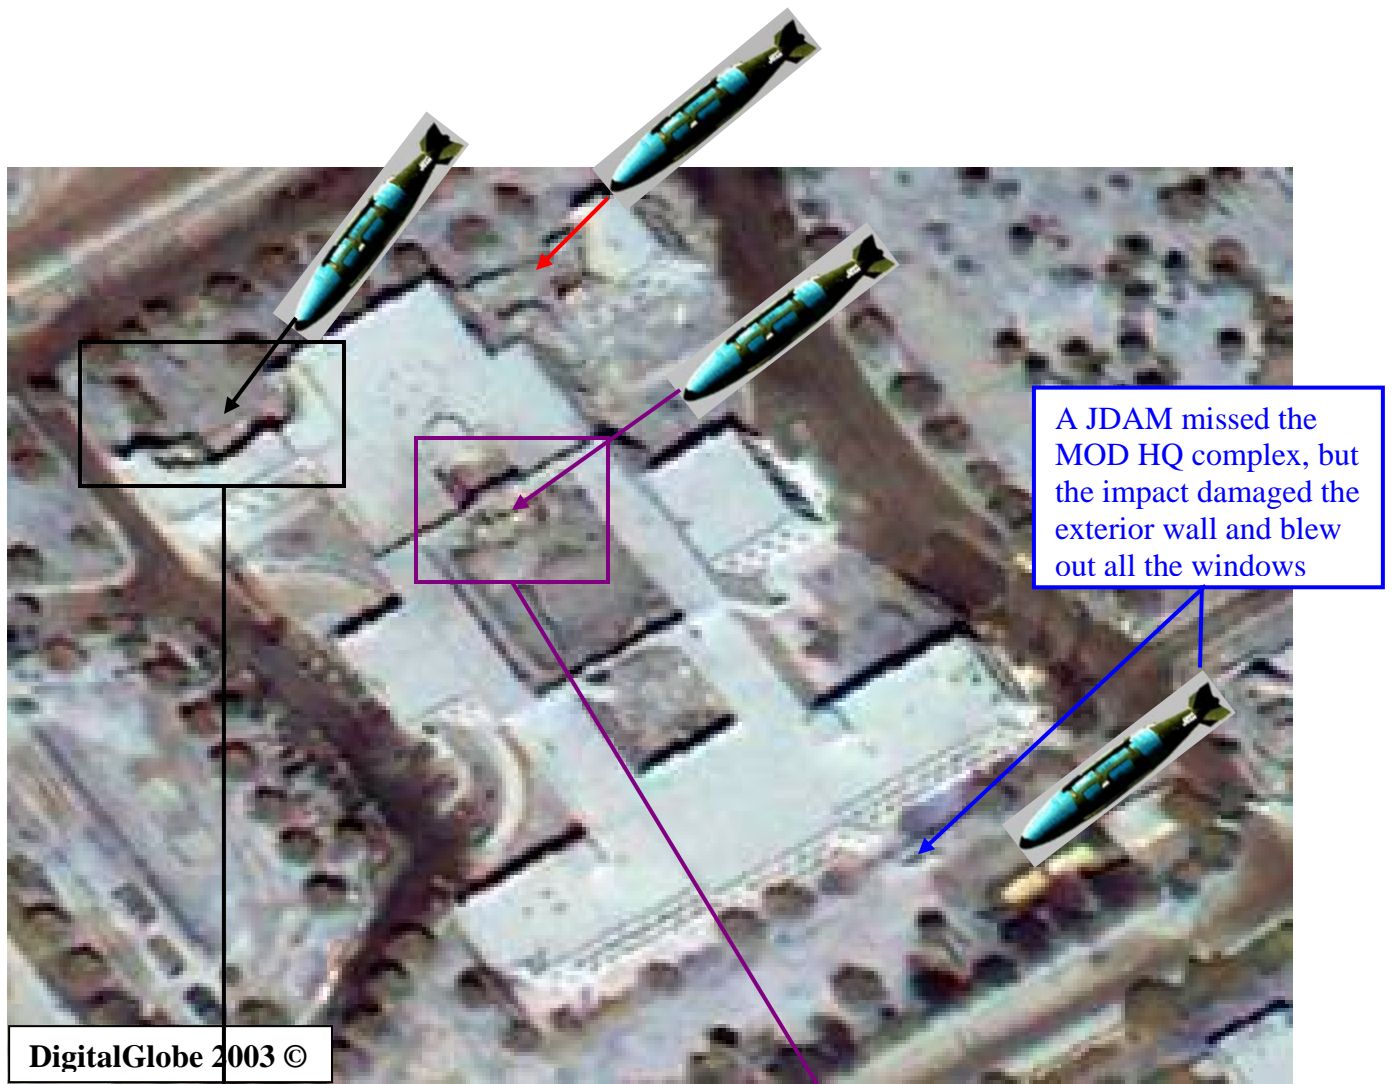
The MOD HQ complex is situated in the International Zone. The facility consisted of an H shaped building with entrance and exit foyers (Aerial Image 1). The original construction of this building started in 1957 and was completed in 1961. This complex received catastrophic damage from both the 2003 Joint Direct Attack Munition (JDAM) bombing barrage of Baghdad and subsequent looting (Aerial Image 2 and Site Photos 1 and 2).

Aerial Image 2. Aerial view of 2003 JDAM bombing damage to the MOD HQ building

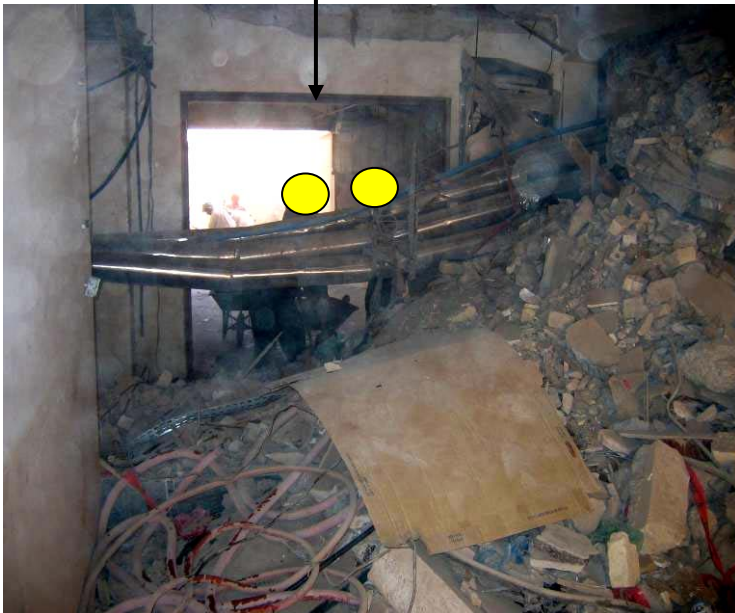
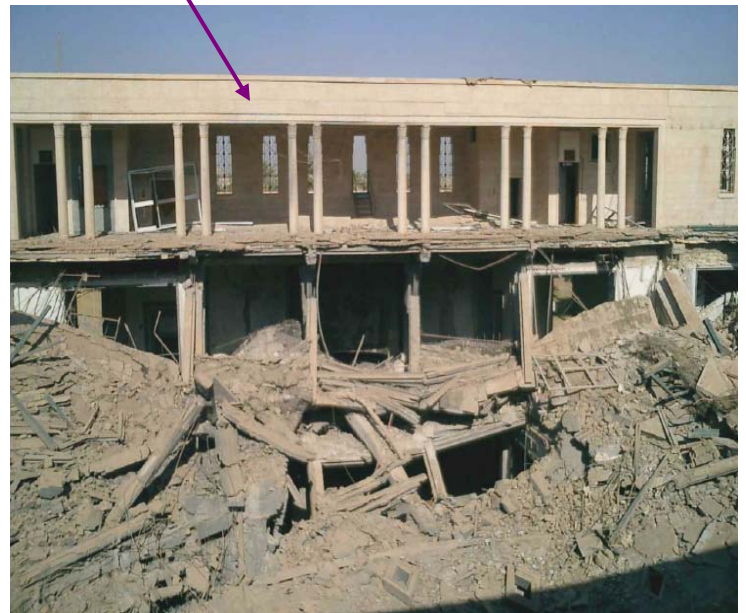
**Site Photos 1 and 2. Interior and exterior JDAM bomb damage to the MOD HQ building
(Photos courtesy of Laguna Construction)**

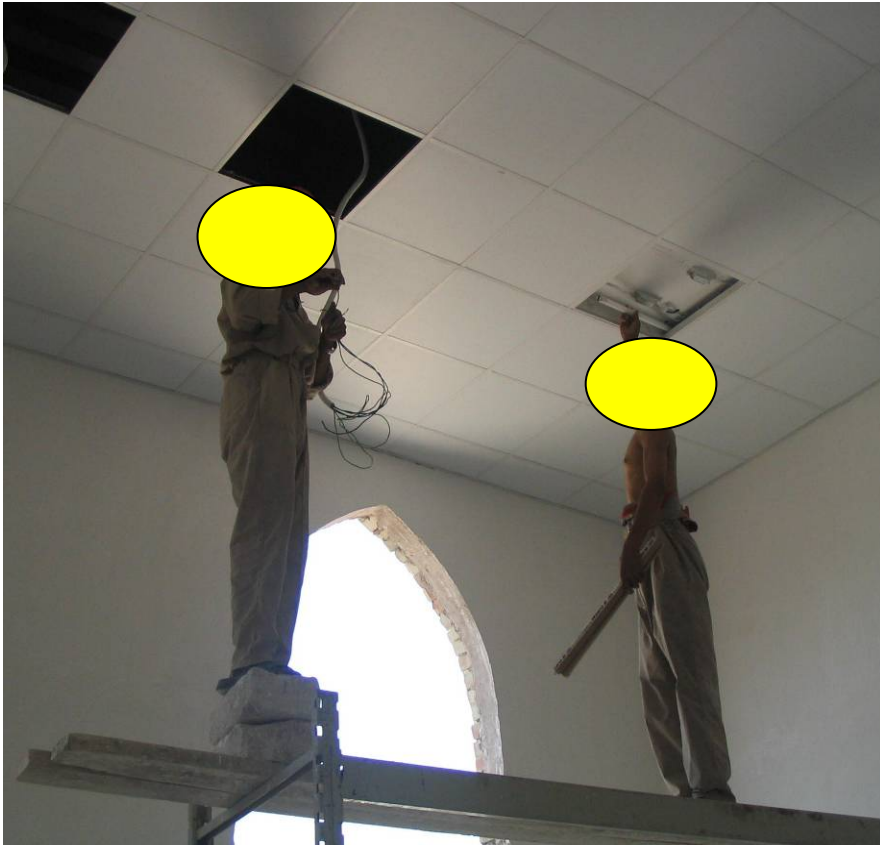
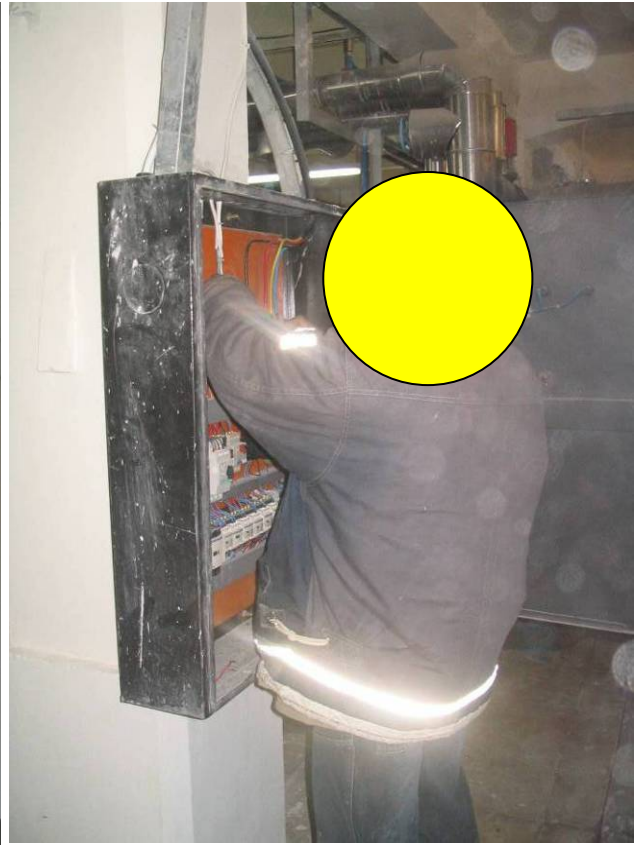
Site Photos 3 and 4 document the installation of electrical wiring within the interior of the MOD building. The installation of air conditioning duct work and the construction of the third floor are captured in Site Photos 5 and 6. Finally, the progression of work on the severely damaged left wing of the MOD HQ complex is shown in Site Photos 7-9.

Site Photos 3 and 4. Installation of electrical wiring in the MOD HQ building (Photos courtesy of Laguna Construction)

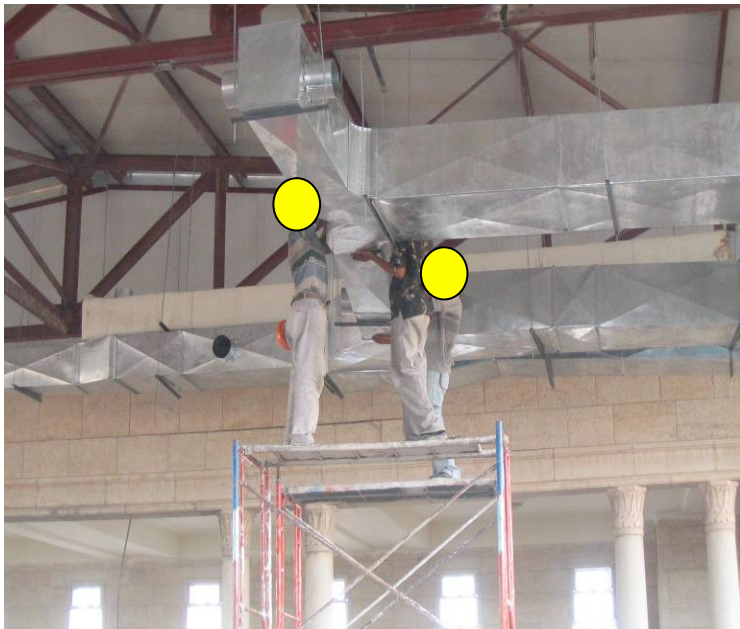
Site Photo 5. Installation of air conditioning duct work (Photo courtesy of Laguna Construction)

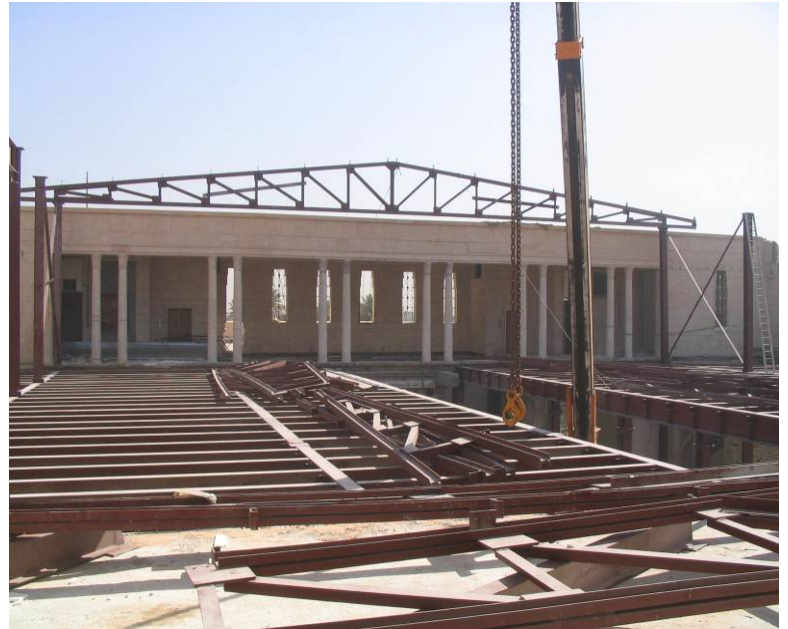
Site Photo 6. Construction of the third floor (Photo courtesy of Laguna Construction)

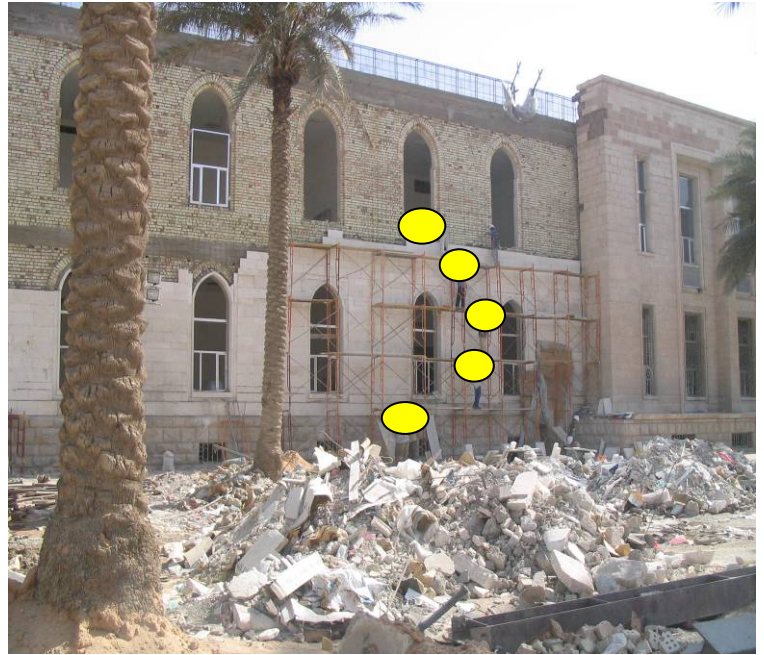
**Site Photos 7 and 8. Early construction work on the severely damaged left wing of the MOD HQ building
(Photos courtesy of Laguna Construction)**

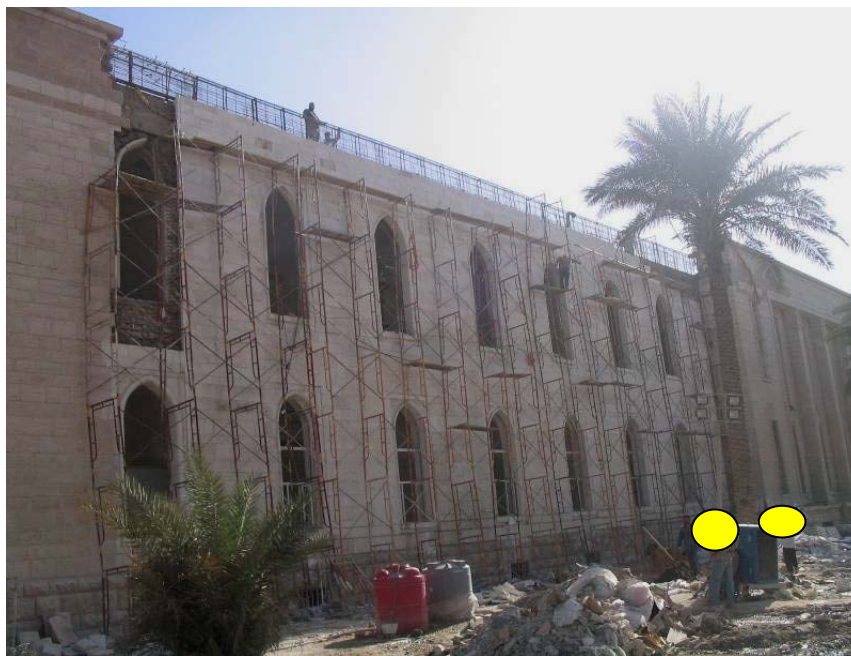
**Site Photo 9. Near completion of the left wing of the MOD HQ building
(Photo courtesy of Laguna Construction)**

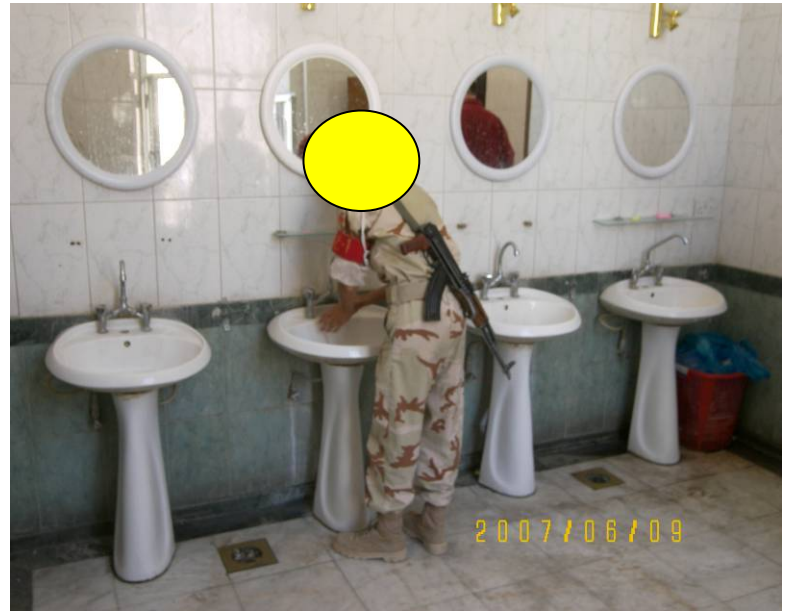
During our site visit, we did not detect any instances of potentially harmful electrical system tampering. Wiring improvements appeared compliant with the SOW requirements. In addition, we tested several toilets and sinks to verify they were fully operational. Interior and exterior plumbing improvements included new toilets, sinks, water heaters, and piping (Site Photos 11 and 12).

Site Photos 11 and 12. Newly installed toilets and sinks within the MOD HQ bathrooms

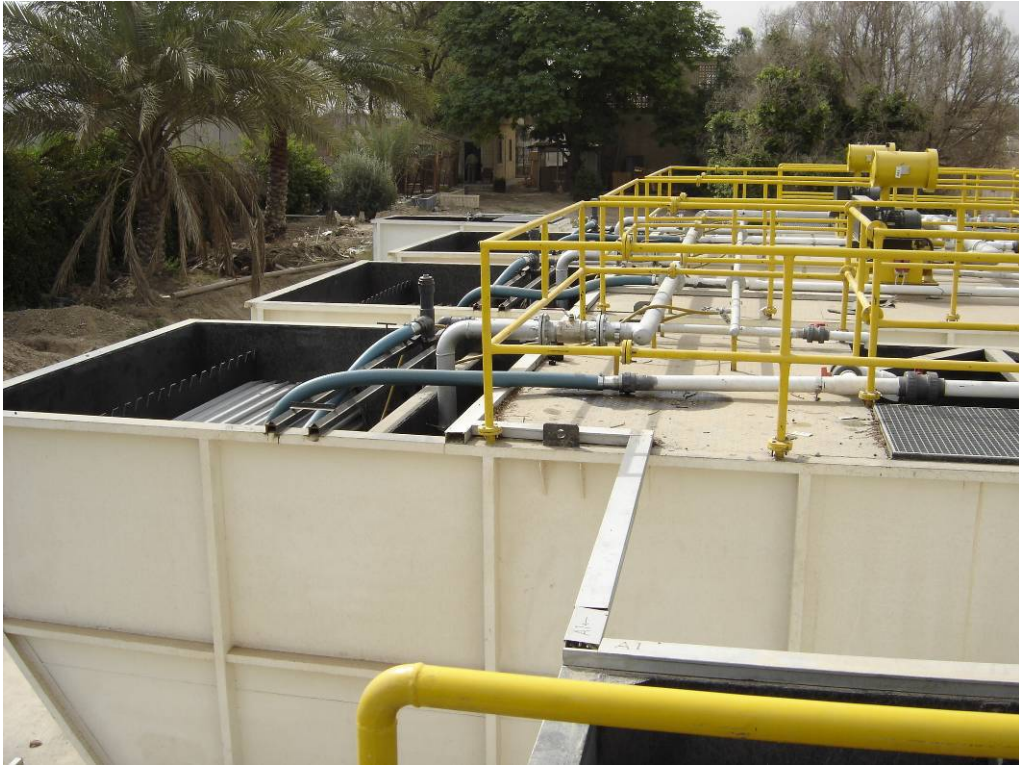
According to the contractor, prior to the installation of the WWTP, all waste water leaving the MOD HQ building was deposited directly into the Tigris River. In order to avoid continuing the practice of depositing untreated waste water into the Tigris River, the contractor-provided packaged WWTP appears to meet the MOD's needs in terms of total waste water volume. This packaged WWTP, located outside the MOD HQ building, captures and treats the waste water before it is discarded into the Tigris River. The design required that a wet-well collect all waste water from the entire building and a sewage lift station, with properly sized mechanical components and pipes, delivers effluent to the packaged WWTP for treatment. We inspected the installed packaged WWTP (Site Photo 13). We did not observe any abnormalities in the present operation of the WWTP nor did the WWTP exhibit any signs of malfunction. The WWTP appeared to be fulfilling its intended operational goals. According to the contractor's site photos, it appears the MOD personnel are performing adequate maintenance on the WWTP (Site Photo 14). Continual maintenance of the WWTP will prolong its life expectancy and effectiveness.

Site Photo 13. Packaged WWTP outside the MOD HQ building

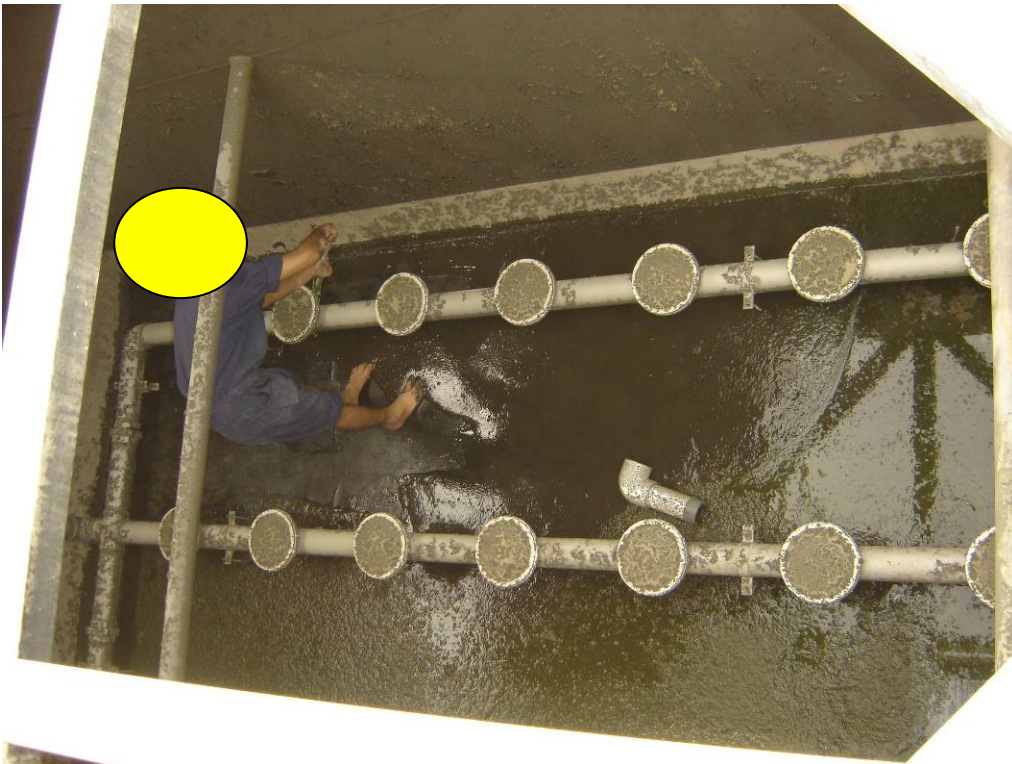
Site Photo 14. MOD personnel performing routine maintenance on the packaged WWTP

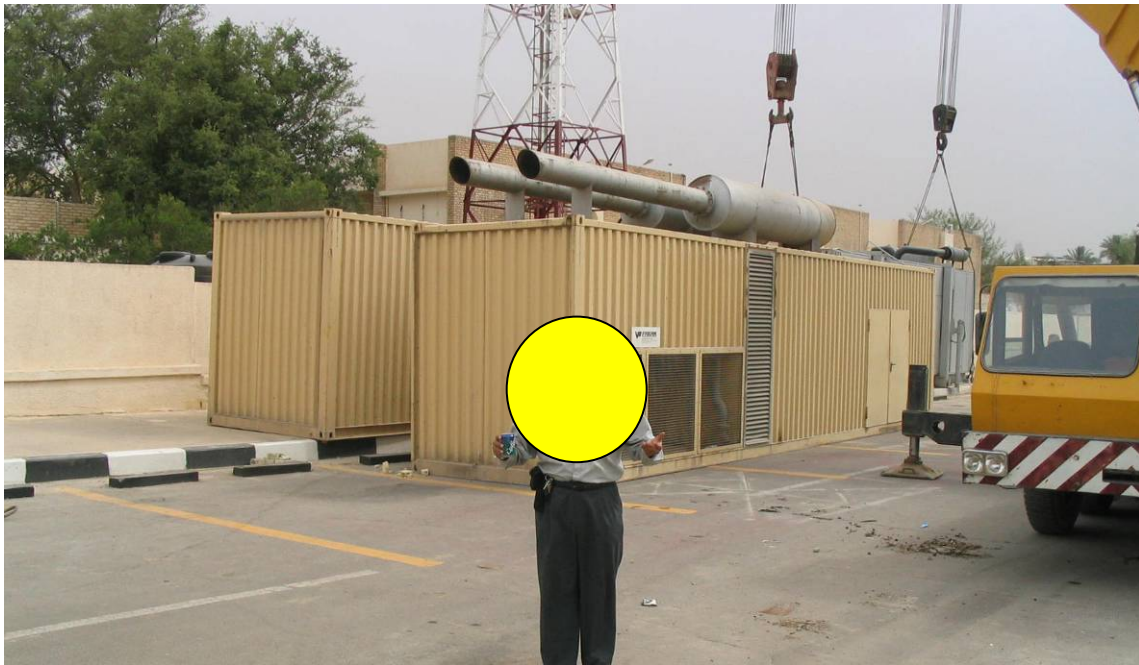
We inspected the MOD HQ building's major support systems, such as lighting, data and voice communication, HVAC, water pumps, and WWTP, all of which appeared to be functioning adequately. The primary source of all MOD HQ building power is the Baghdad power grid; however, it is also supported by two 2-Megawatt (MW) generators and other lesser capacity generator sets. The contract required the refurbishment of two existing large generators, which were successfully commissioned with the required automated controls and transfer switches (Site Photo 15). At the time of our visit, the MOD HQ building was operating off of the Baghdad power grid; consequently, we were unable to observe the functioning of special controls and transfer switches that bring the generators on line. However, MOD personnel stated that the generators and transfer switch system were operational and continuously used when the Baghdad power grid was down¹.

**Site Photo 15. Contractor repositioning the refurbished two 2-MW generators
(Photo courtesy of Laguna Construction)**

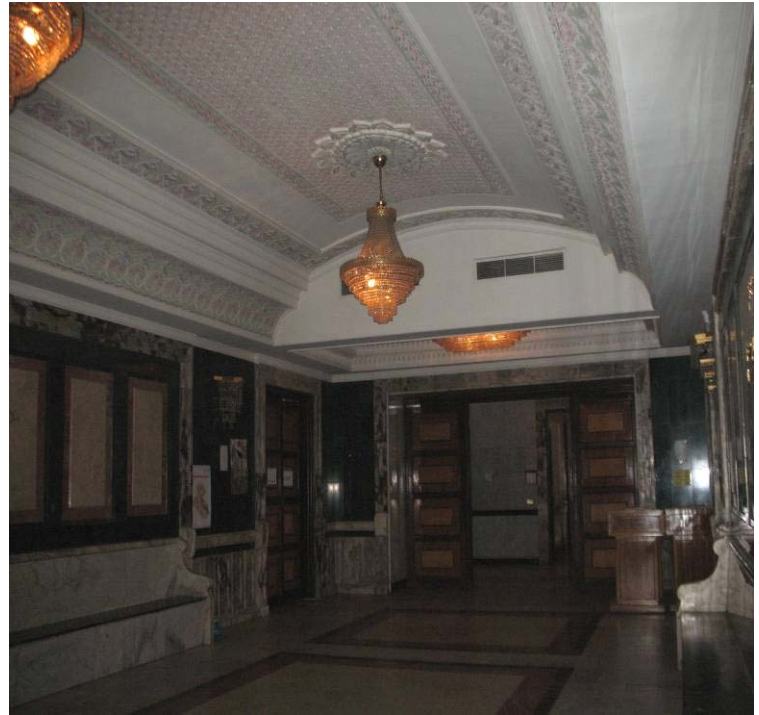
Site Photo 20. Newly renovated ceiling

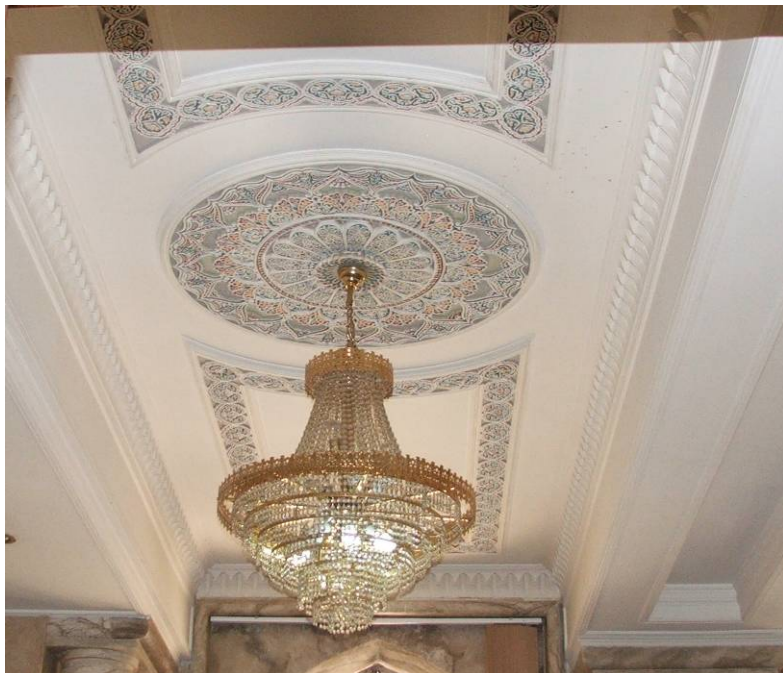
Site Photo 21. Ceiling tile and light fixture

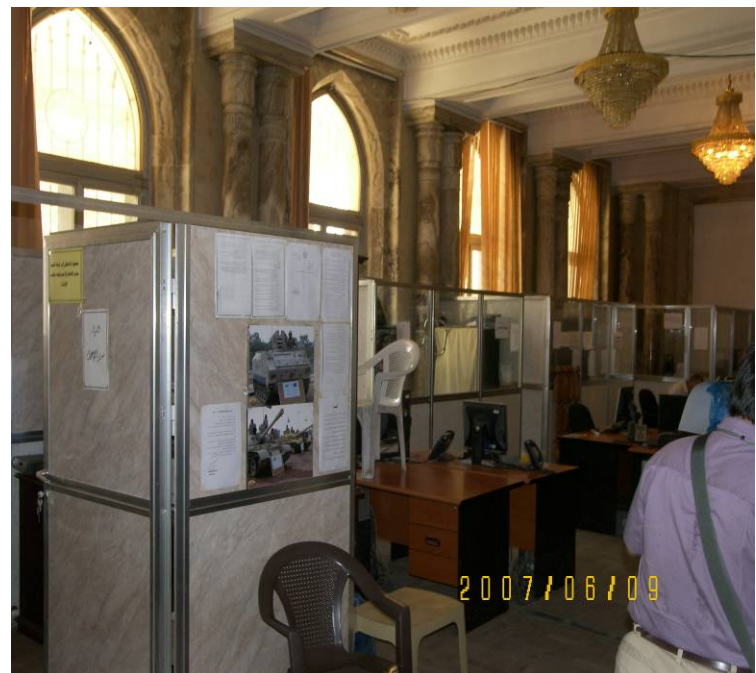
According to the contractor and MOD officials, the current usage of the building far exceeds the original intent of providing working space for approximately 450 MOD personnel. It is currently estimated that more than 3,000 MOD personnel now work in the MOD HQ building on a daily basis. However, accommodations for the additional MOD personnel were made without major disturbance to the contractor's work. For example, large ballrooms were turned into office space through the use of cubicles (Site Photo 22).

Site Photo 22. Interior ballroom turned into additional office space through the use of cubicles
